Re-vegetation of Brine Damaged Soil: A Soil Rebuilding Approach.

Rene Bernier, Jim Myers, ChevronTexaco, 4800 Fournace Pl, Bellaire TX 77401-2342
Jerry Hall, Entrix Inc., 5252 Westchester, Suite 250, Houston, TX 77042-5865 770

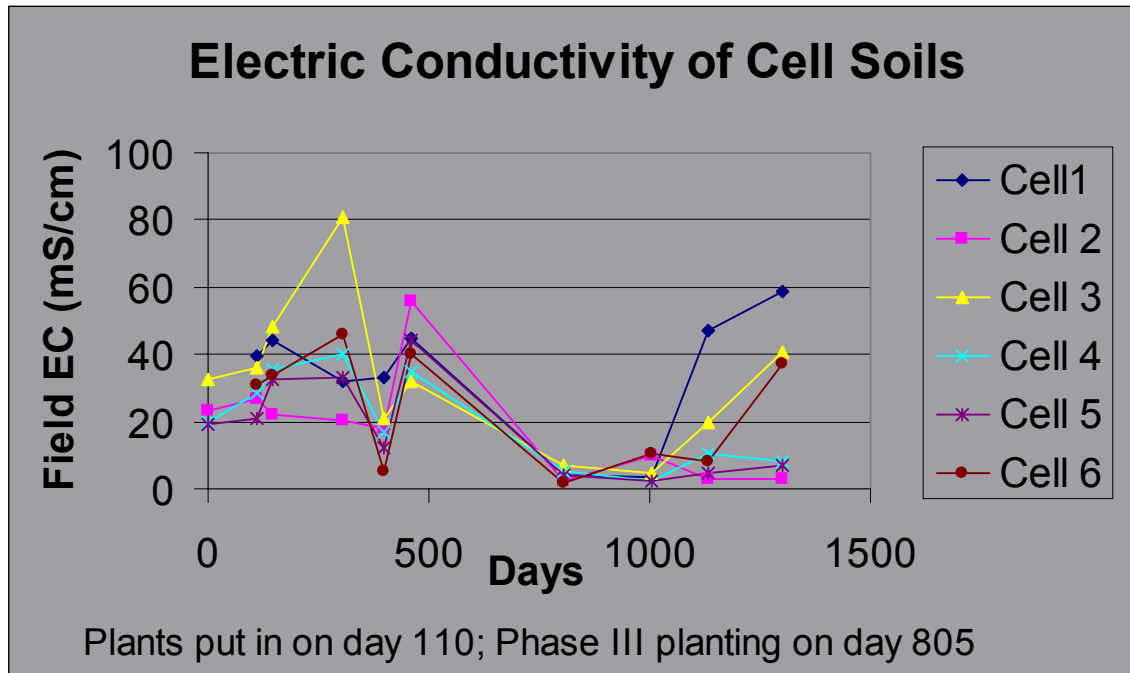
Figure 1 Electric Conductivity of soils in the Phase I planting plots throughout the study

The impact on salt was measured by determining the EC of the soils. The salt impact over time is presented in Figure 1

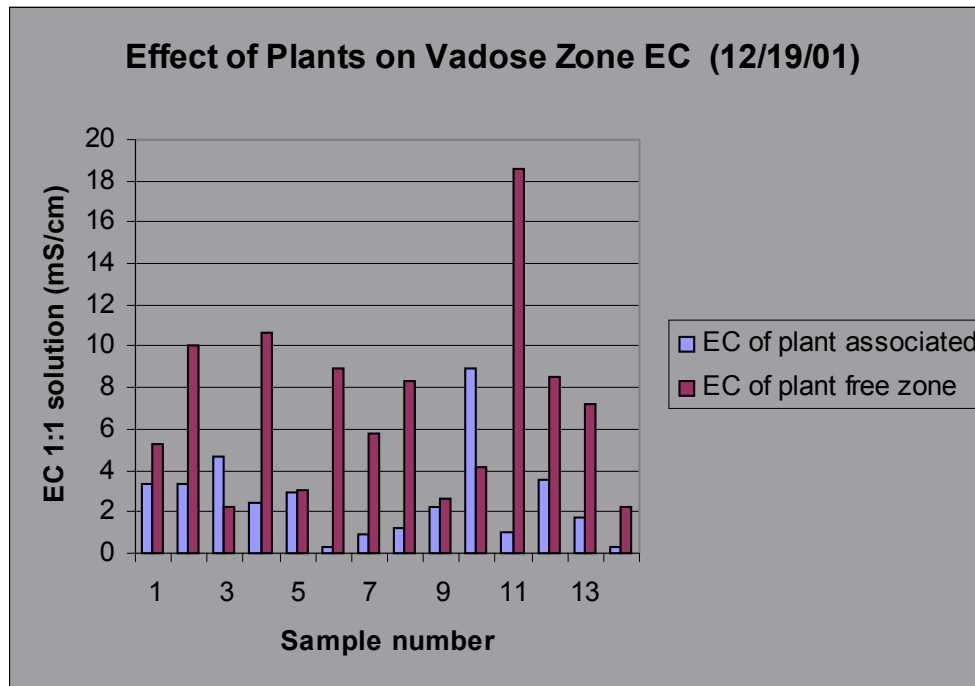
Figure 2. Effect of *S. patens* on the electric conductivity of soils immediately around plants

While evaluating the survival of plants during the one year monitoring event, we also evaluated the impact of *S. patens* on the EC of soils (Figure 2). The electric conductivity of soils within the rhizosphere was significantly lower than the electric conductivity of soils that are not impacted by the plants. The electric conductivity of the rhizosphere soils was approximately one third of the EC of soils 3-4 feet away. Secondary growth of less salt tolerant plants has begun to fill into the areas between *S. patens*.

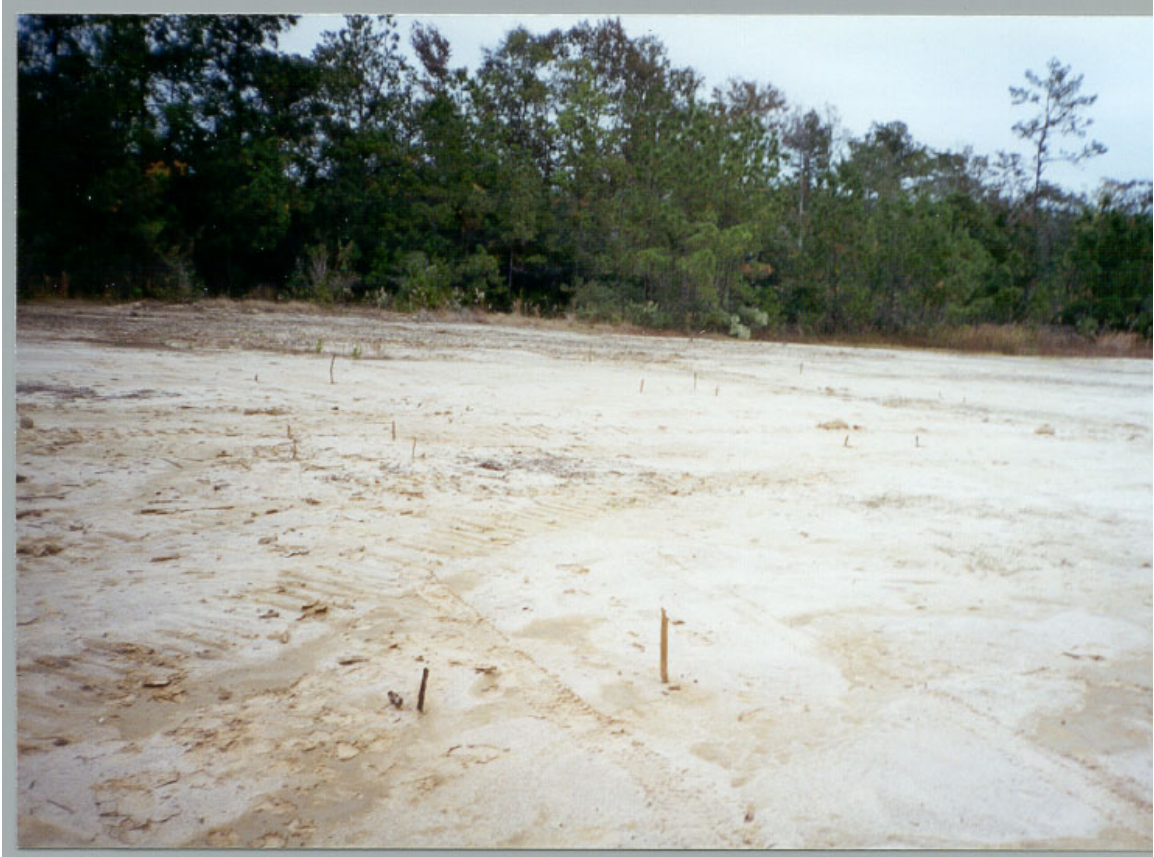
Figure 3 Initial condition of the site.

The site used in this study was a historical crude oil producing field in Southwest Louisiana. Leakage from brine tanks led to salt contamination of surrounding soil and the loss of vegetation in an area of about two acres. The surrounding habitat is upland forest predominantly vegetated with Loblolly Pine. Initially, no vegetation was found on the site, with the exception of two Salt Cedar trees approximately three m in height.

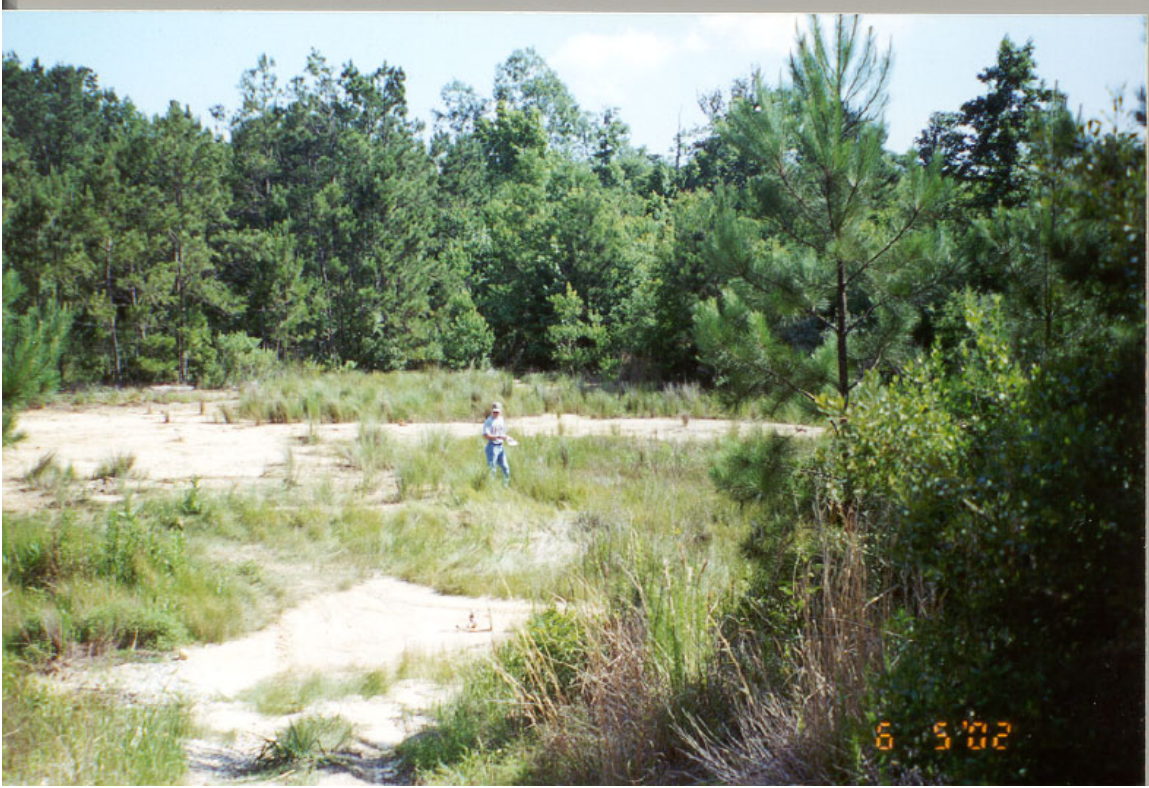
Figure 4 Same area of the sight Eighteen months into Phase 3

Spartina patens proved to be a resilient plant that could survive the heat and drought conditions found in south Louisiana in 2001. It proved to be able to survive the high saline conditions of a brine contaminated soil. We are currently very optimistic about the complete revegetation of this site. Based on the success of the revegetation to date it is likely that total coverage may be obtained in the near future. Figures 3 and 4 document the overall improvement in the soil coverage at this site. Figure 3 indicates that there are no plants growing on large areas of the site. Figure four is the latest monitoring with almost full coverage in most areas.
