Vadose Zone Remediation by Passive Soil Vapor Extraction (PSVE)

MicroBlower™

- Solar powered soil vapor extraction
- U. S. Patent 6,971,820

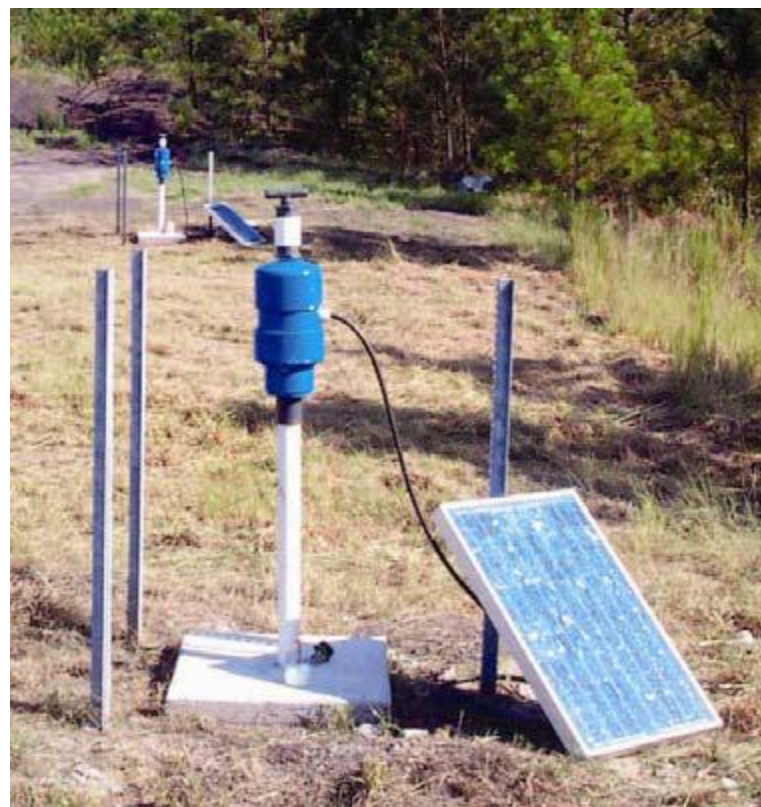
MicroBlower™

- Used to Enhance Soil Vapor Extraction
- Intermediate technology between traditional electric and barometric pumped systems

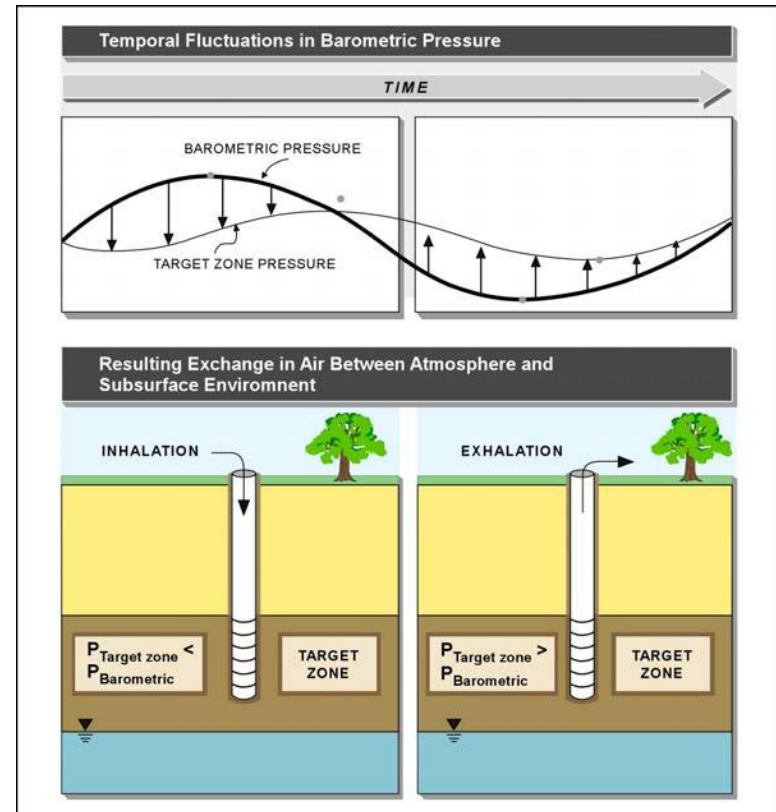
Conceptual Model for the 'Inhalation' and 'Exhalation' Phenomenon Vadose Zone Wells

- Dynamic flow of air from the zone of high pressure to the zone of low pressure

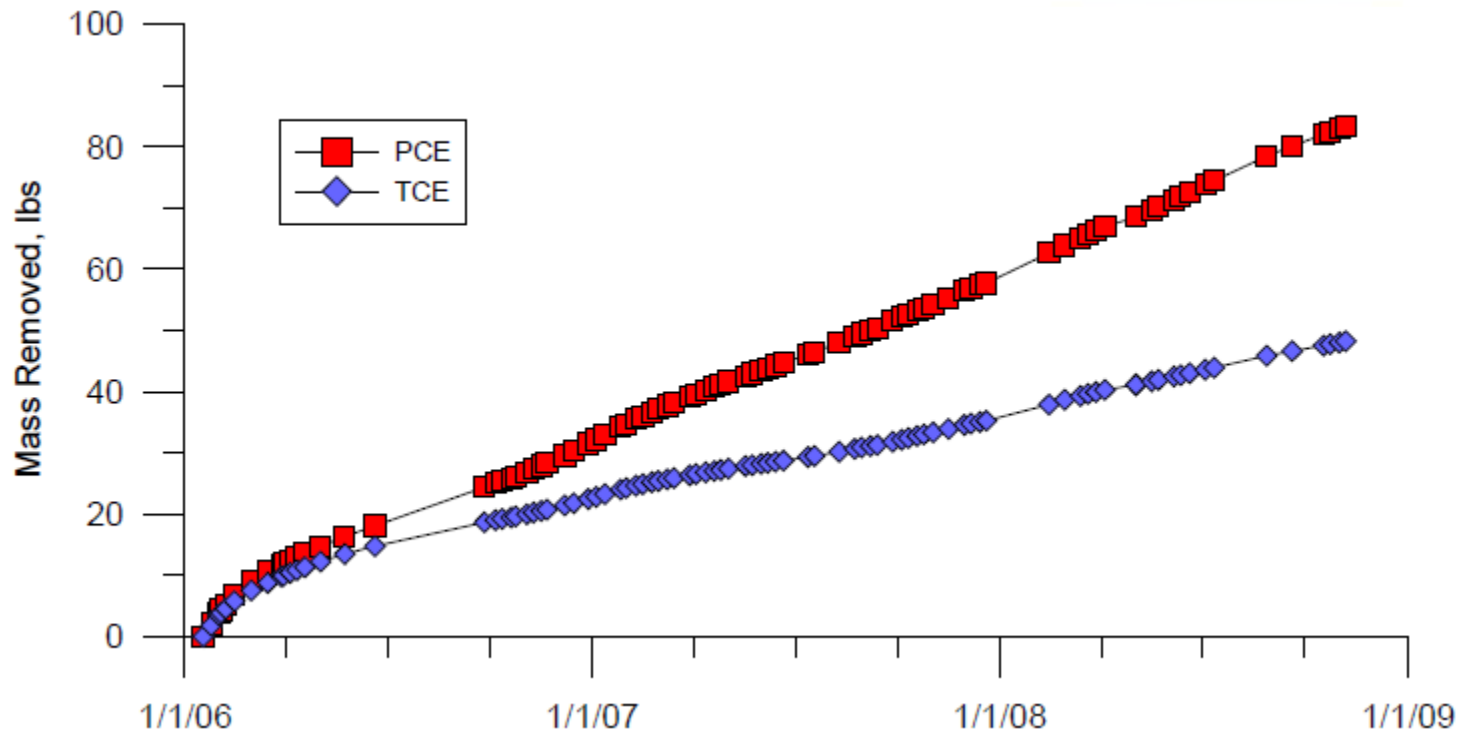
VOCs Removed

234 pounds removed in 10 months

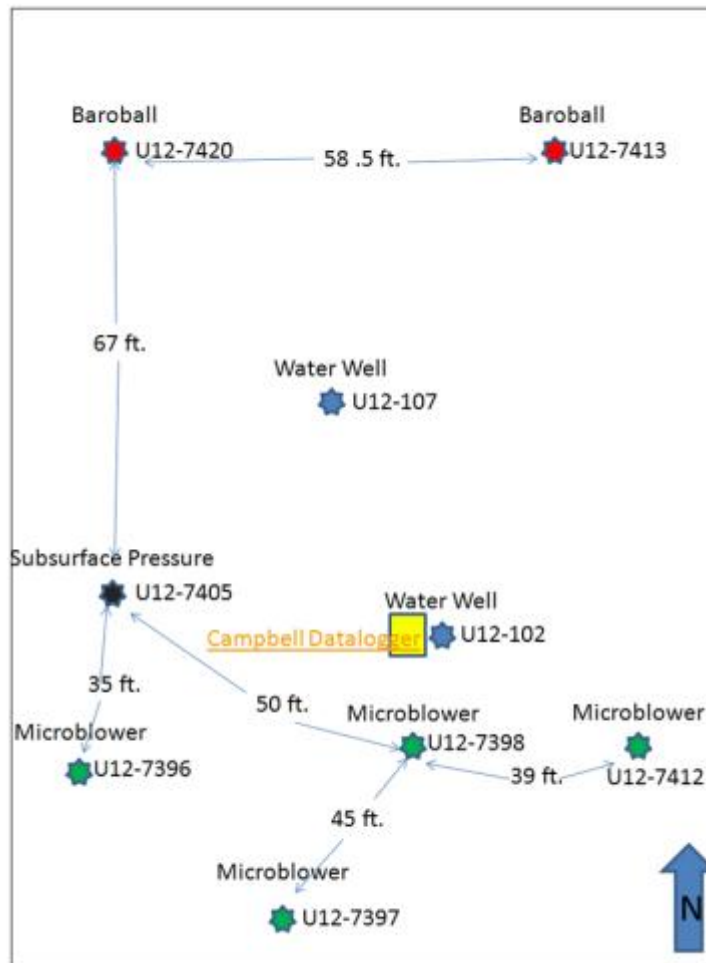
Well Layout

Passive SVE Demonstration at AF Site

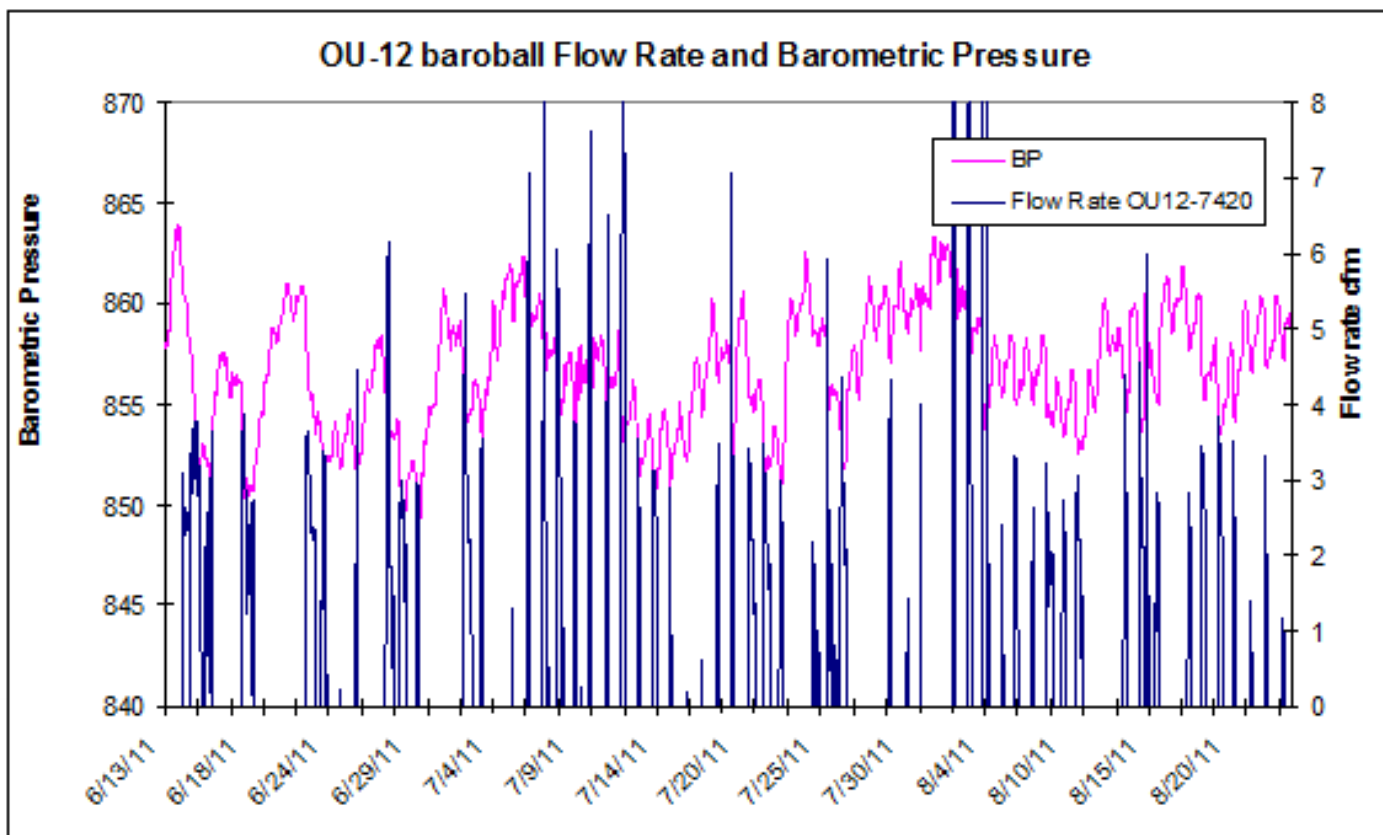
OU12-7420

Flow Rate (cfm) from Baroball Wells

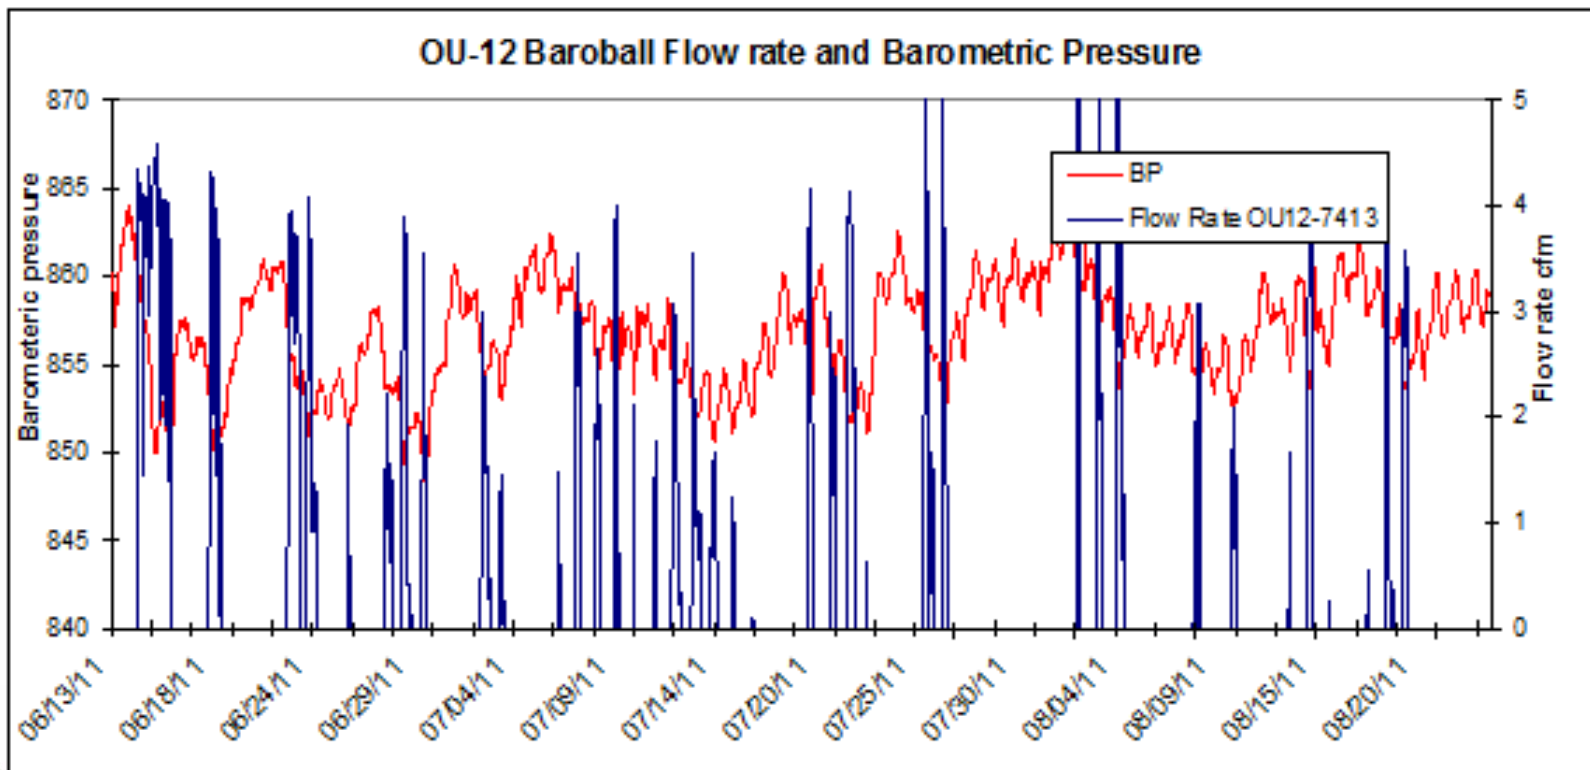
OU12-7413

Flow Rate (cfm) from Baroball Wells

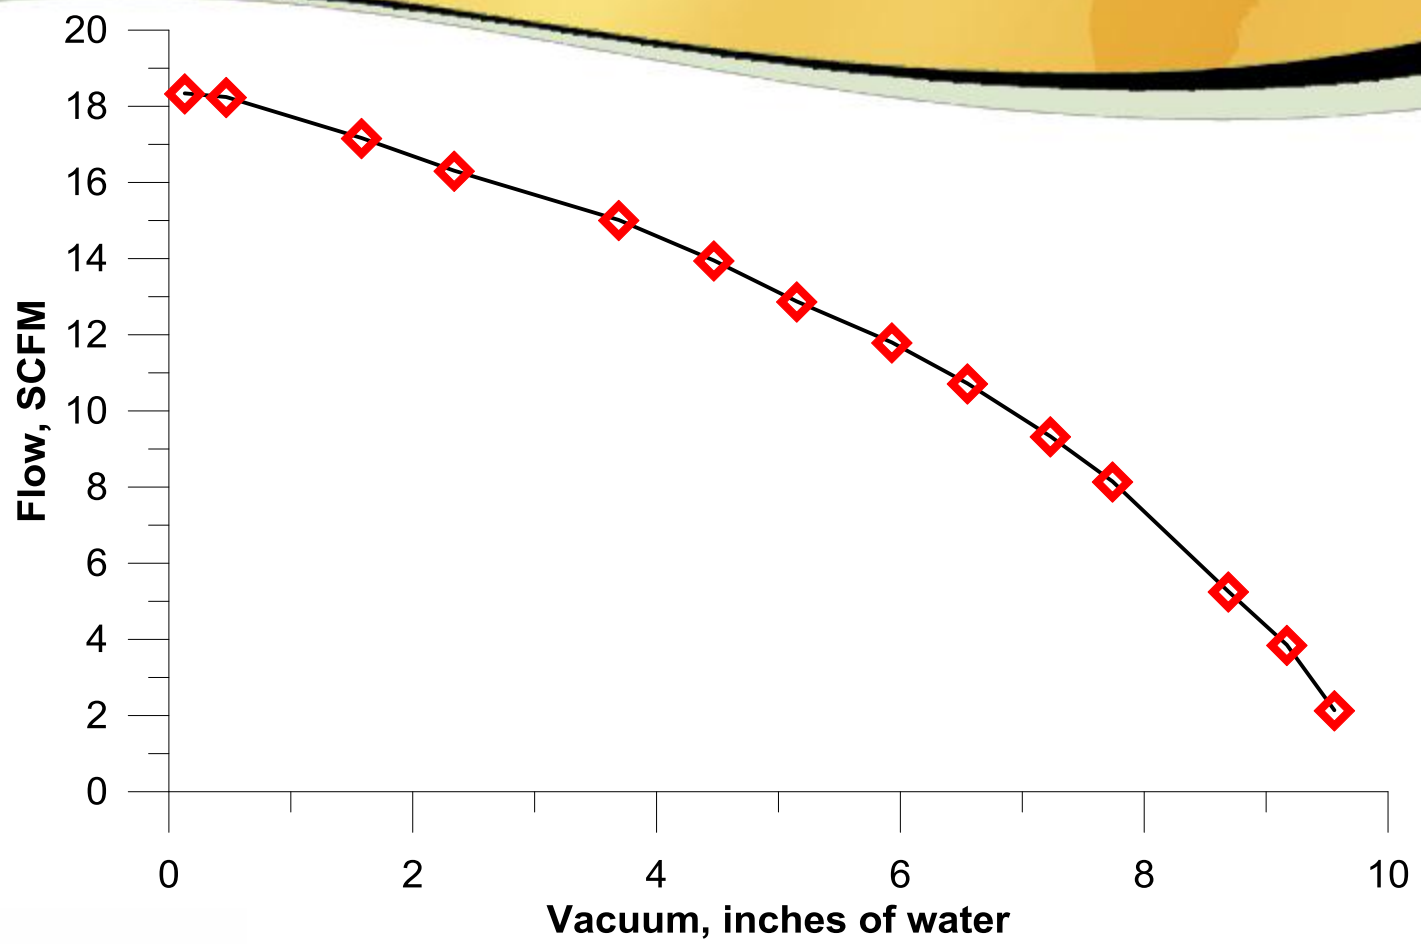
Performance Curve

24 V System
