Fiber Rolls as a Tool for Re-Vegetation of Oil-Brine Contaminated Watersheds

Period Covered by the Report: 01-14-2006 to 04-14-2006

EPA Grant Number: X83-2428-01

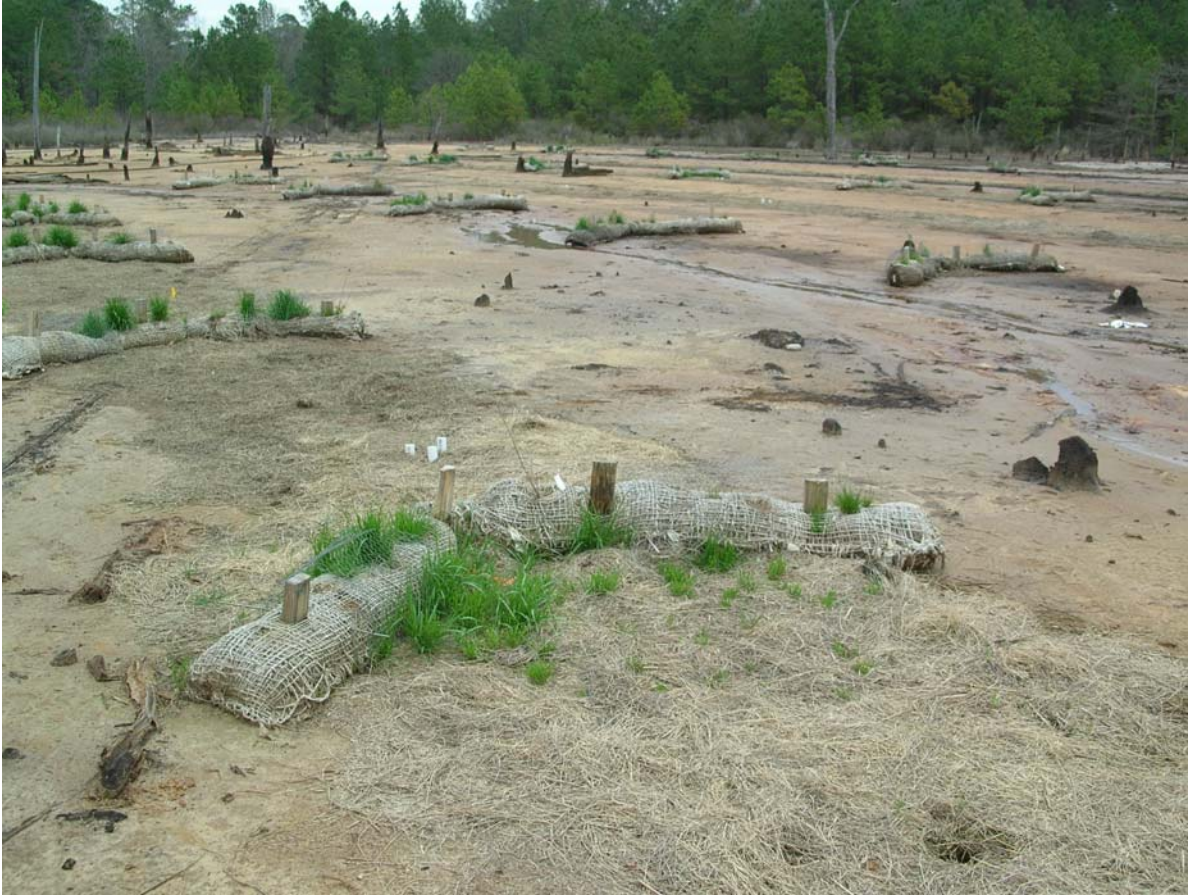
Figure 1. Fiber rolls ca. 20 weeks after planting. Rolls are located in an historic brine scar in south Arkansas.

Approximately 20 weeks after plants were placed in fiber rolls, mean vegetative cover (\pm SE) per roll was 14.5 (\pm 1.3) %. The majority of the vegetation was composed of grasses that had spontaneously germinated from hay seed. Preliminary analysis indicated that soil amendments did not affect plant cover within rolls. The lack of effect probably indicates that plant roots have not significantly moved beyond the organic matter in the rolls and onto the soil. Alternatively, the quantity of nutrients and organic matter in the rolls may be sufficiently large that the soil treatments did not affect plant performance within the rolls. Plant cover between fiber rolls in plots that received tilling, chicken litter and hay was greater than plots receiving rolls only or soil amendments only ($p=0.0026$). Plot surfaces that received no treatment, surfaces in plots between rolls without soil treatments and surfaces in plots receiving soil amendments only exhibited no plant cover.

No breaks were detected in the fiber rolls at the time of the first assessment.
